**WINNIPEG**  
**Air Testing**

August 21, 2020

Project Number: R12345

## MOISTURE SURVEY IN BATHROOM

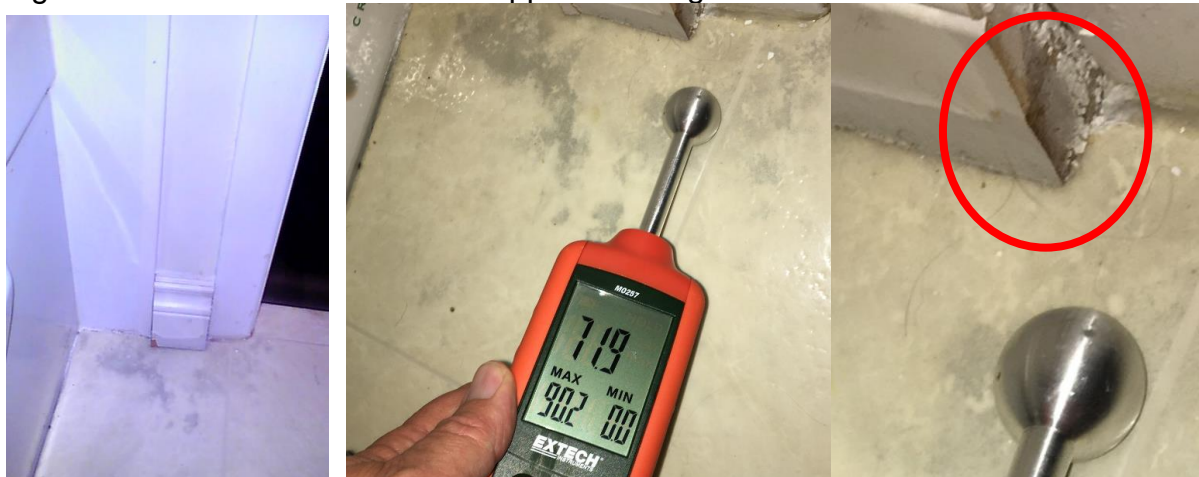
An inspection of the bathroom was performed using a moisture meter and an infrared camera. Both the wall/floor beside the bathtub and the bottom of the vanity cabinet had high moisture content that would support mould growth.

**Left.** Adjacent to the bathtub, visible discolouration of the floor can be seen. **Middle.** A moisture measurement shows high moisture content in the floor (72% moisture content). **Right.** A magnified image shows that the baseboard is visible wet.

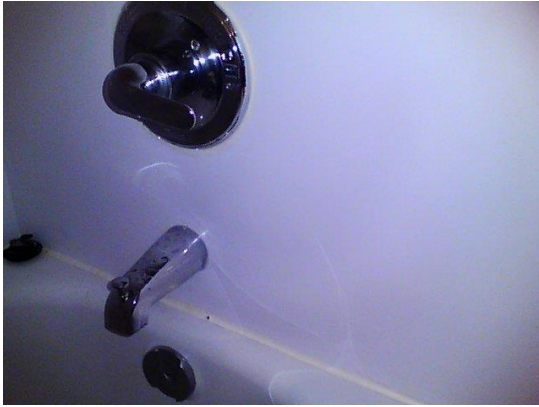
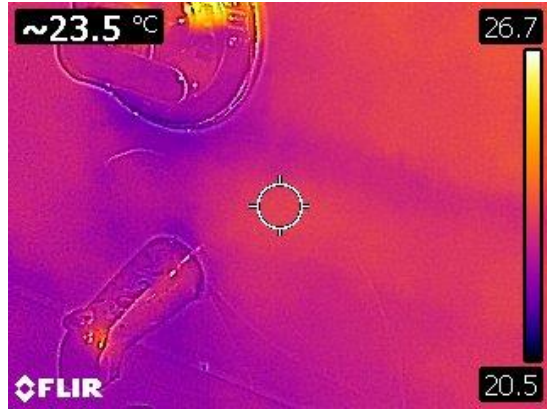
**Above.** The bathtub wall is dry to the touch. The infrared camera (right image) shows irregular cold areas that are very likely water leakage inside the shower wall. The purple lines indicate water leaking down from the shower control and seeping to the right.

There is clear presence of moisture issues in the bathroom. Although water damage can be seen on the floor, the source of the water damage is a leak inside the wall at the shower control lever.

Parameter	Findings	Comments
Observations	Serious Problem Some Issues Normal	Indication of moisture issues. Some water staining on the floor linoleum.
Infrared Camera	High Significant Normal	Infrared camera shows evidence of water leakage from plumbing inside wall.
Moisture Measurements	Moisture Problem Slightly Elevated Normal	Significantly elevated levels of moisture in floor and wall beside bathtub.
Action	Corrective Action No Action Required	The plumbing leak should be fixed and the wet materials dried or replaced.

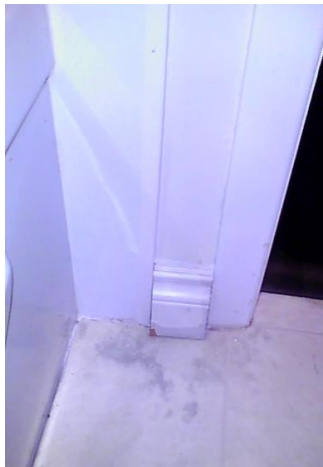
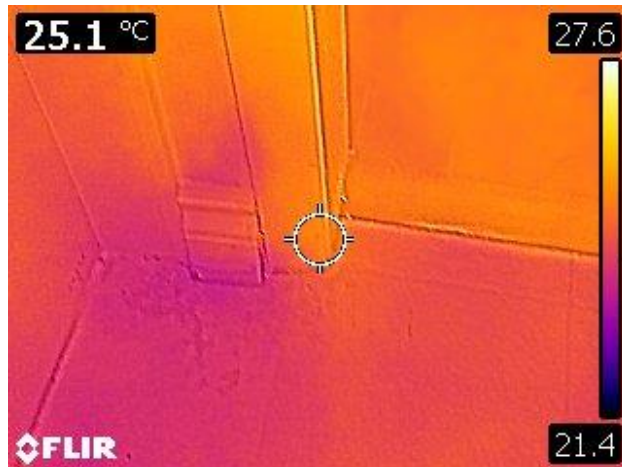
**Above.** Adjacent to the bathtub, visible discoloration of the floor can be seen. The infrared camera shows the floor and the lower part of the wall to be cold due to presence of moisture.
