January 20, 2020
Project Number: 4322

Asbestos Audit of 123 My Street, Winnipeg, MB

On January 14, 2020, a pre-demolition asbestos audit was performed by Winnipeg Air Testing at 123 My Street in Winnipeg, Manitoba. The purpose of the survey was to locate and collect bulk samples of suspect asbestos containing materials to identify where asbestos was present in the building.

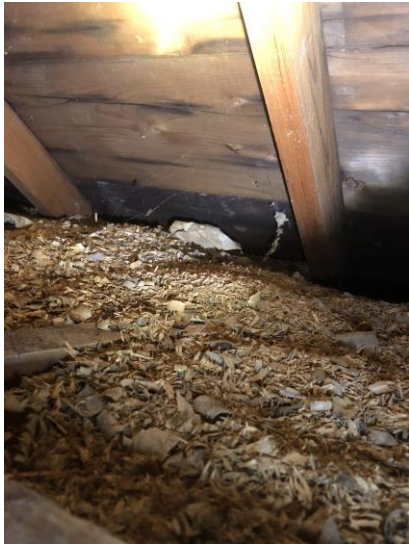
Left. Attic with woodchip insulation. No vermiculite insulation was observed.

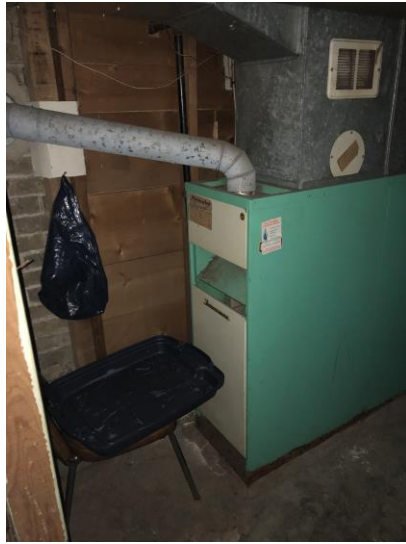
Center. Natural gas furnace with no pipe or boiler insulation.

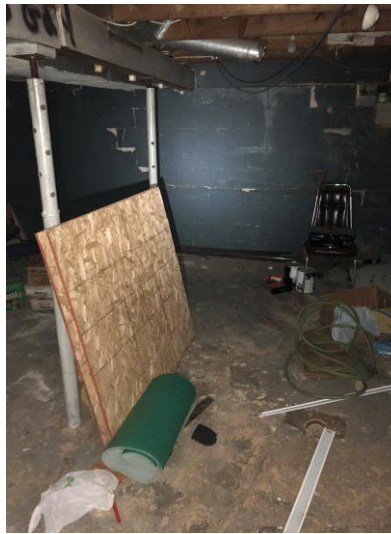
Right. Basement with concrete walls and floors.

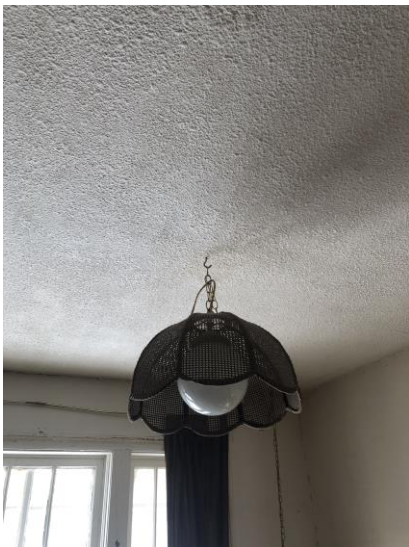
Left. White ceiling stipple in the living room. No asbestos was detected in this material.

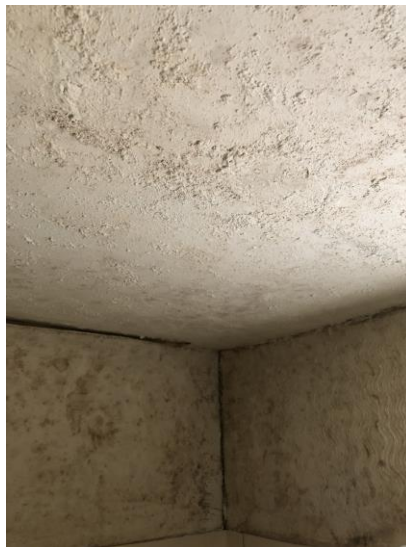
Center. Tan ceiling stipple in the bathroom, asbestos was detected in this material.

Asbestos was detected in the tan ceiling stipple in the bathroom and the brown floor linoleum. Precautions should be taken when disturbing or abating these materials. The Province of Manitoba has developed a guideline for an asbestos management program. This document provides additional information for the property owner.

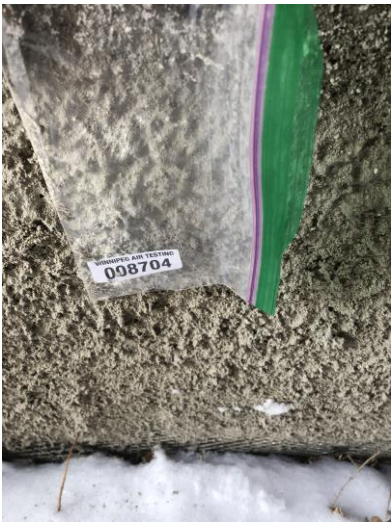
Right. Sample 8704 of the brown base exterior stucco. No asbestos was detected in the sample. Plastic panels were also found on the exterior.

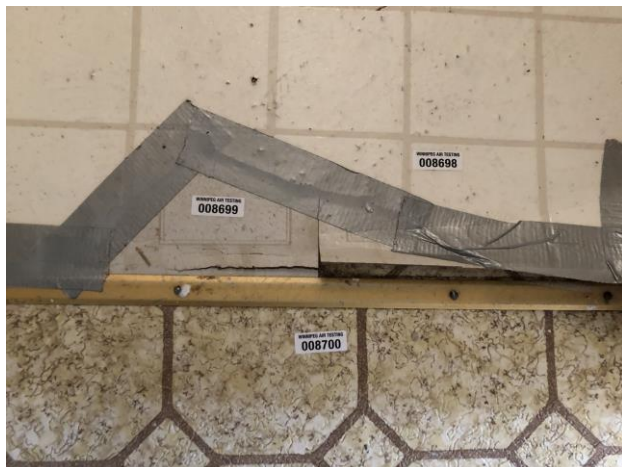
Left. Samples of floor linoleum. Samples 8698 and 8699 from the bathroom did not contain asbestos. Sample 8700 of the brown floor linoleum contained 20% Chrysotile asbestos. This flooring was also found in the kitchen.

Right. Sample 8702 of the wall plaster by the back door. No asbestos was detected in the sample.
