October 5, 2020 Project Number: R12239

MOISTURE SURVEY

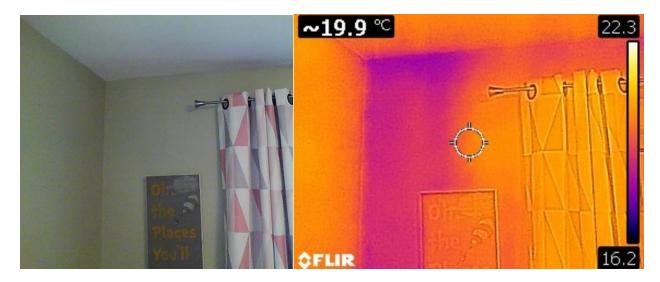
An inspection of the home performed using an infrared camera found cold spots in two rooms. The wall of the second bedroom had elevated moisture content of 30% - 35%. Mould growth generally starts around 20% moisture content. Images and infrared images of the wall are provided below. The purple area in the infrared image is the area of elevated moisture content. That corner of the second bedroom backs onto the closet of the master bedroom.

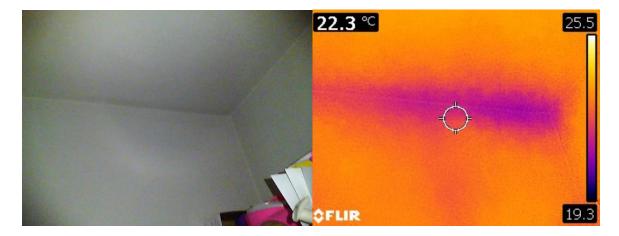
The top left corner of the master bedroom closet (shown in picture and infrared image below) had a small presence of elevated moisture.

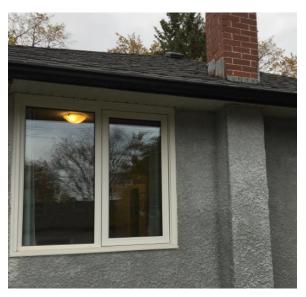
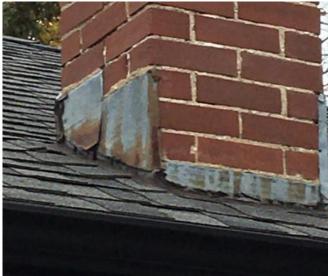
The images below show the outside of the second bedroom window. The chimney is located along the edge of the room. The flashing on the chimney may be the source of the water intrusion. If so, this is a relatively quick and inexpensive repair.
