## Sometimes it's Not Mould

A homeowner was concerned about mould growth around their windows. The windows have condensation during the winter months and discolourization along the window sill. Tape lifts were taken to determine to confirm that the discolourization was mould and to identify the type of mould

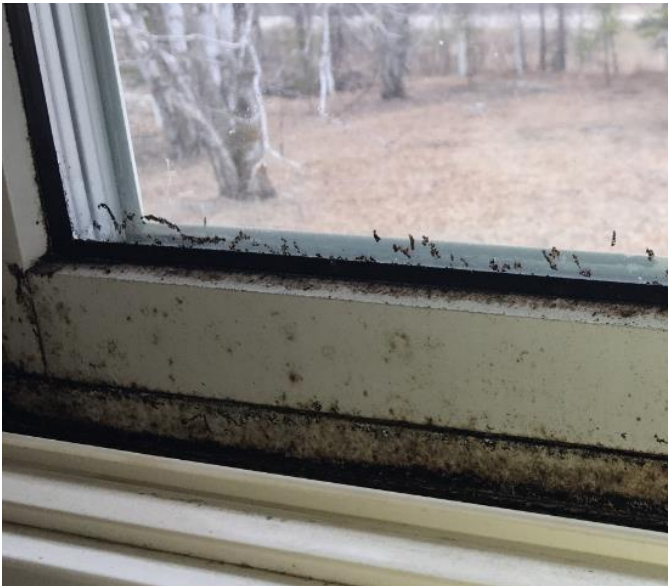
As it turned out, the discolourization was largely insect debris. The image on the right below shows one of the dust mites found in the tape lift. Dust mites are strong allergens and can produce health effects similar to exposure to mould. Now that the issue has been correctly established, a proper course of action to eliminate the problem could be taken.
